FOURTH ENDORSEMENT on NAAS Kingsville AAR ser 13-57
concerning TV-2 BuNo 138043 accident occurring 17 Jul 57

FIRST ENDORSEMENT on NAAS Kingsville AAR 13-57, concerning TV-2, BuNo
138043, accident occurring 17 July 1957, pilot HASKINS

CRAFT ACCIDENT REPORT

B-6 Crash landing (flame-out)

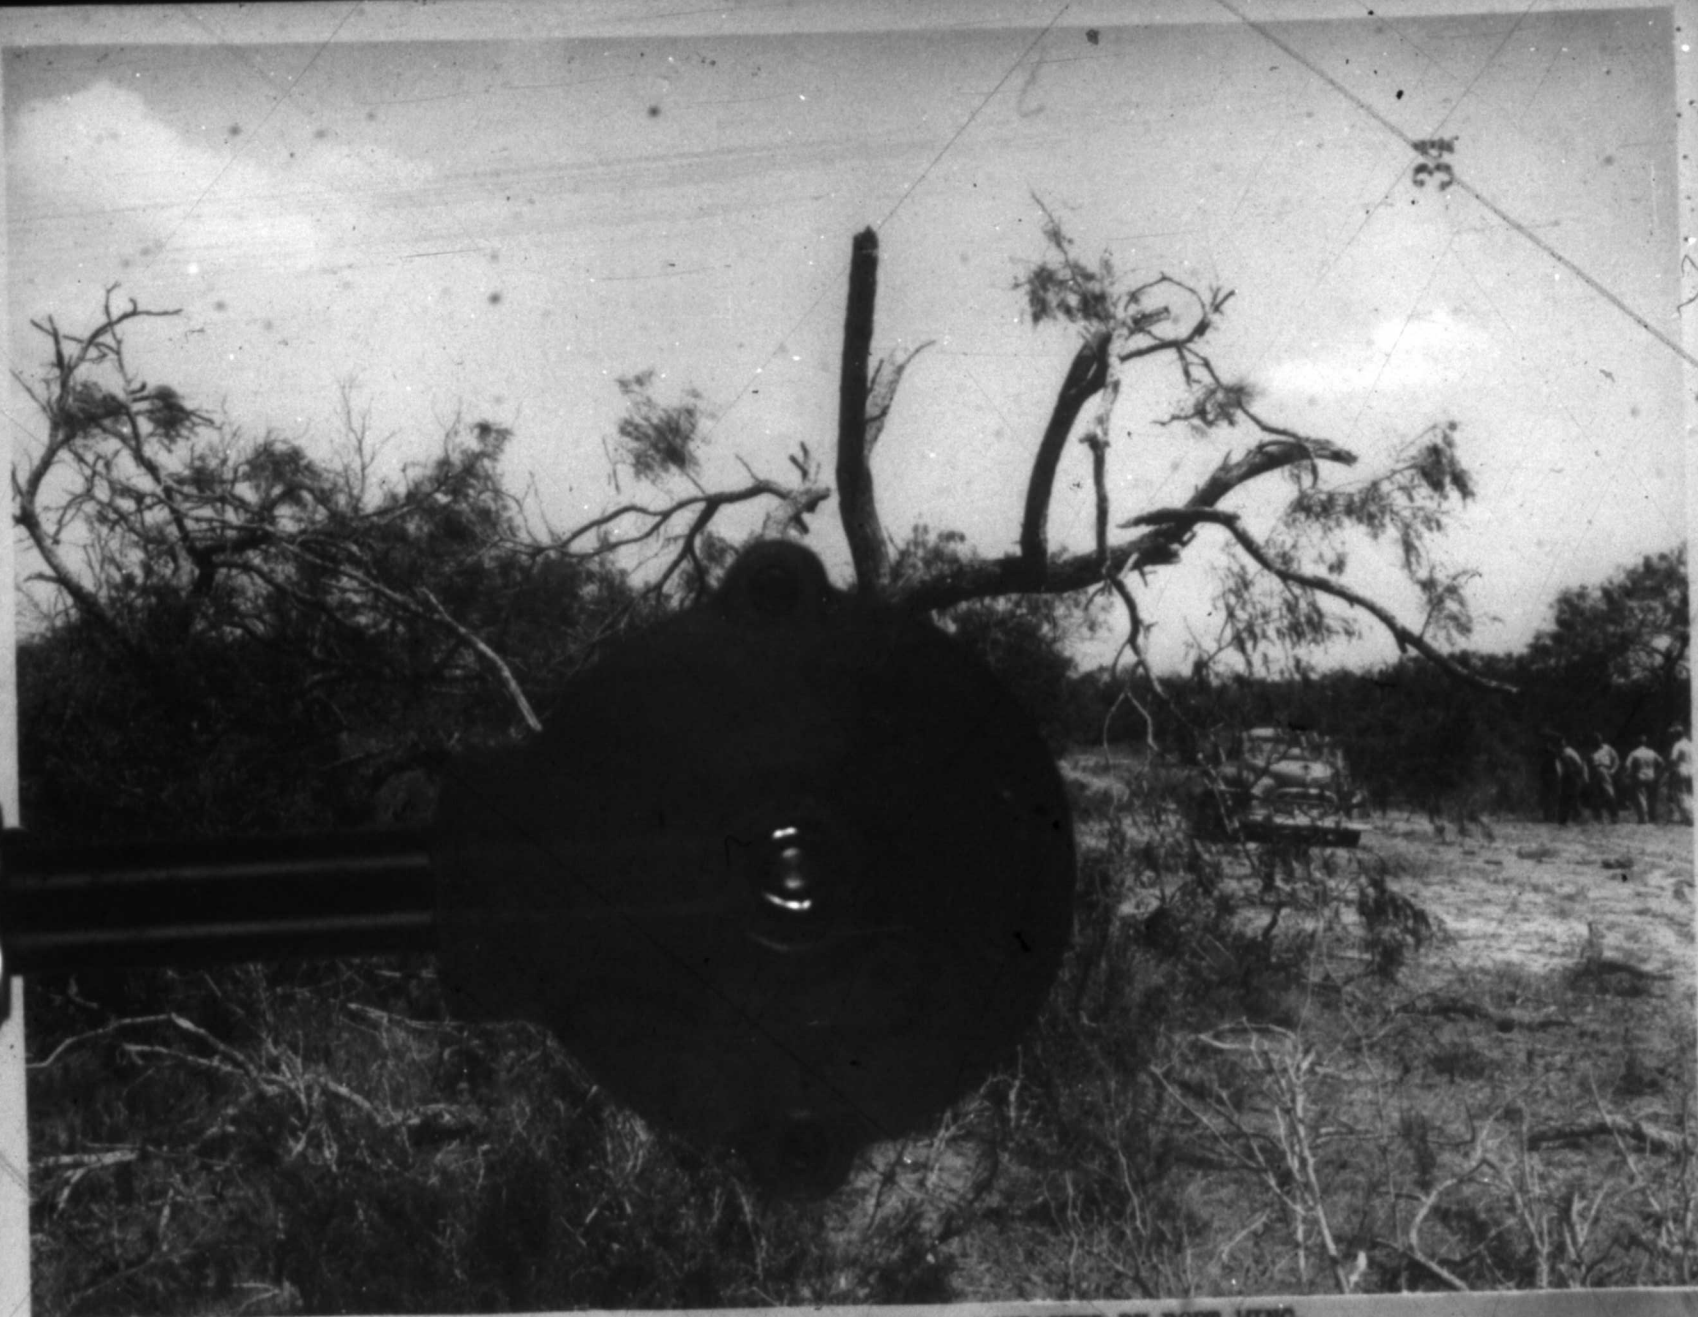
ENCL (10) AAR 13-57 TV-2 BU#138043. FIRST TREE - CONTACTED BY PORT WING.

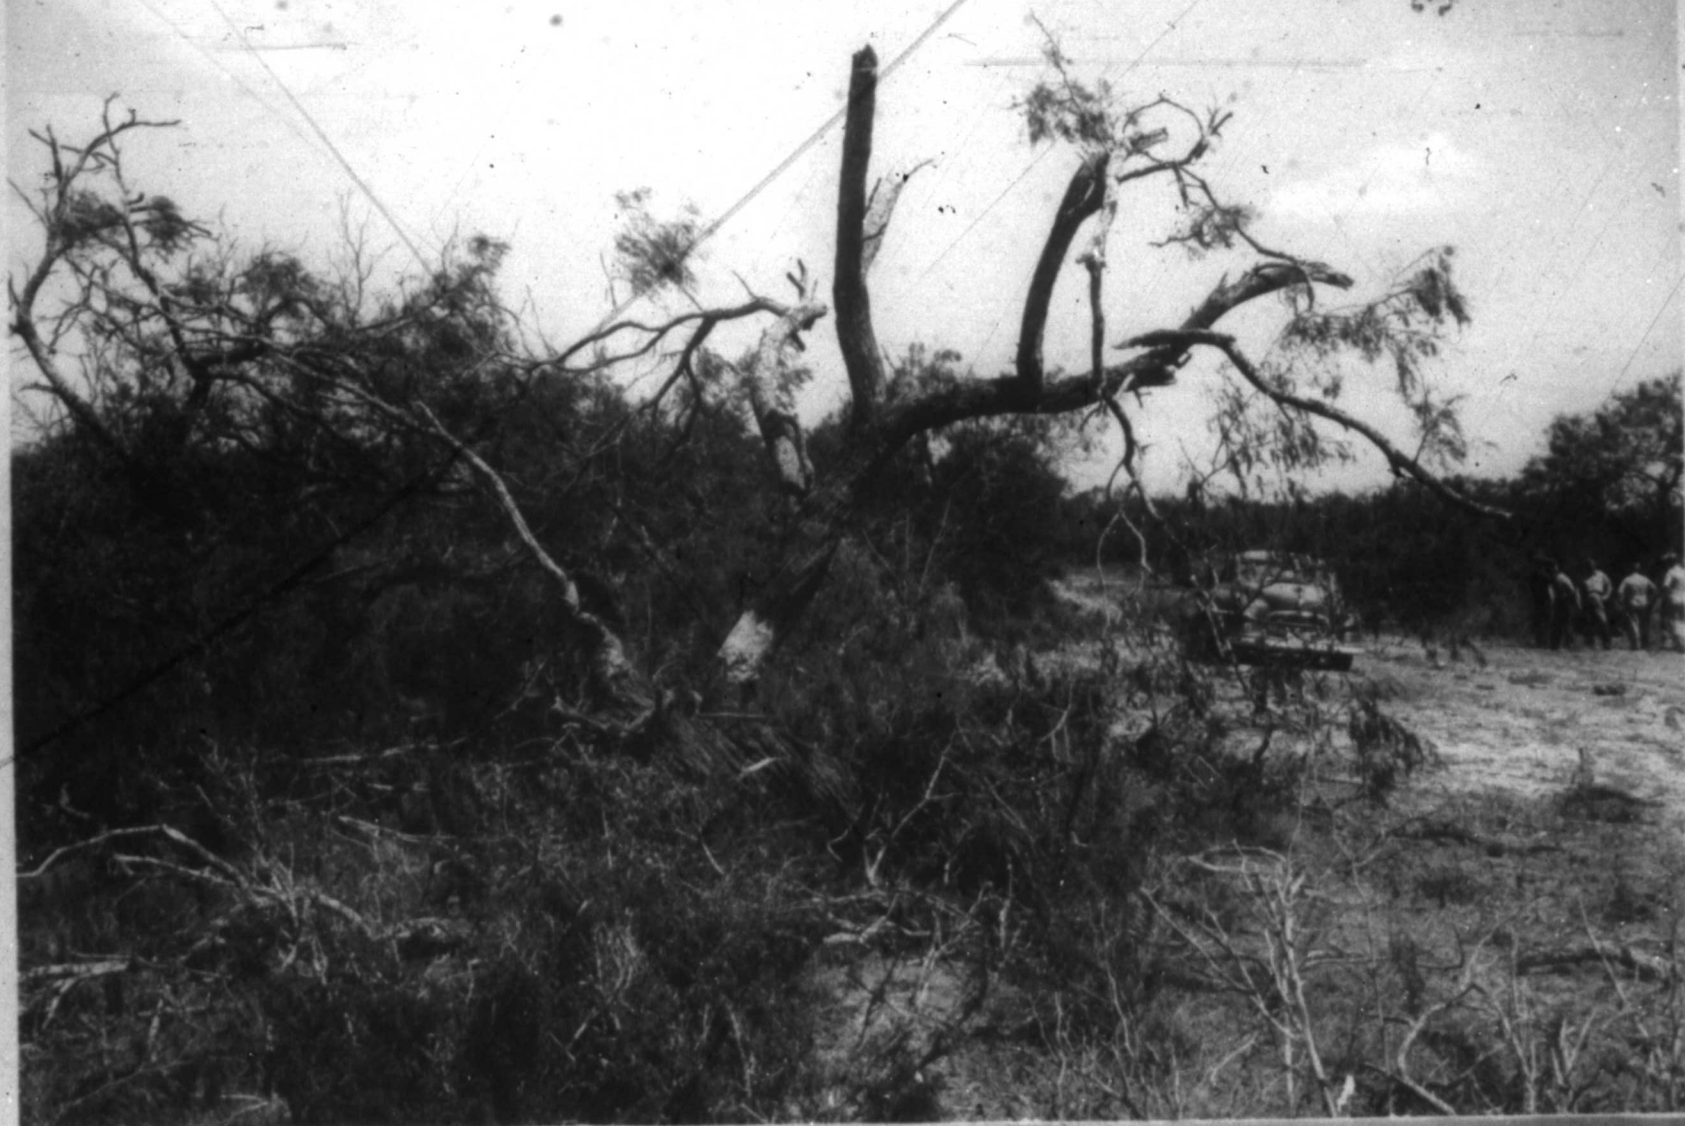
ENCL (10) AAR 13-57 TV-2 BU#138043. FIRST TREE - CONTACTED BY PORT WING.

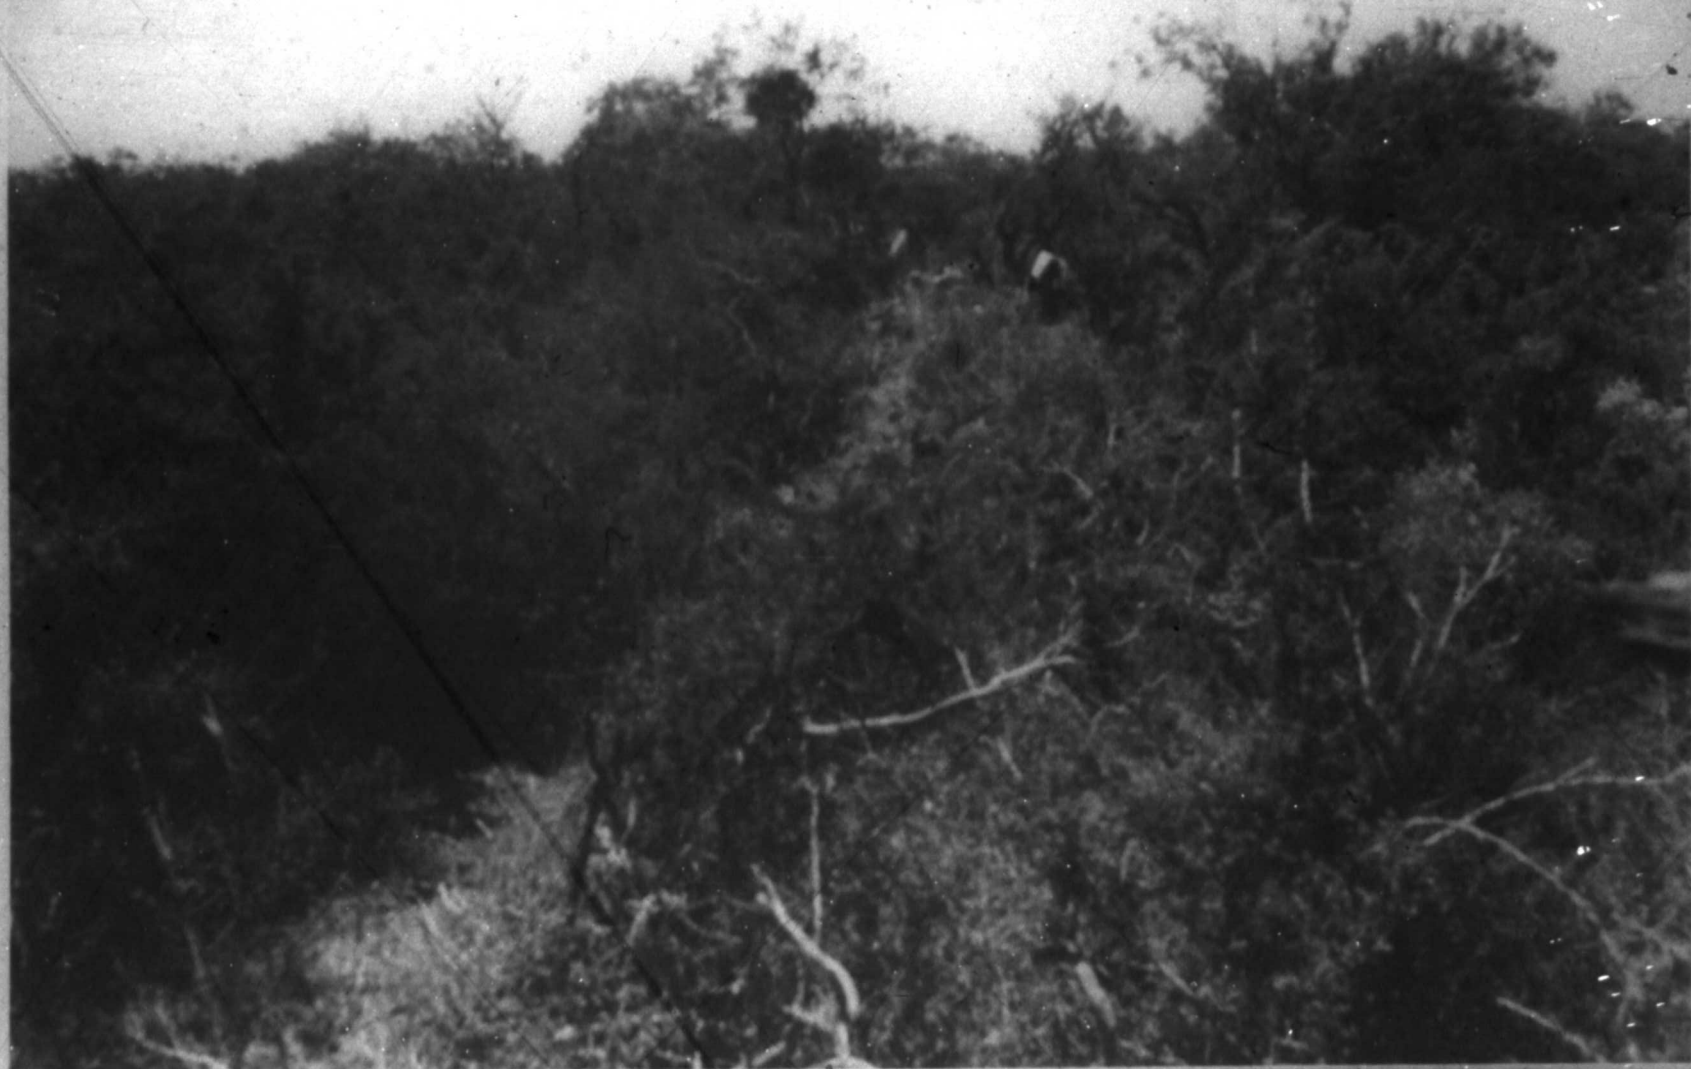
ENCL (13) AAR 13-57 TV-2 BU#138043. VIEW FROM THIRD TREE LOOKING NORTHWEST SHOWS
FLIGHT PATH AFTER CONTACT OF THIRD TREE.

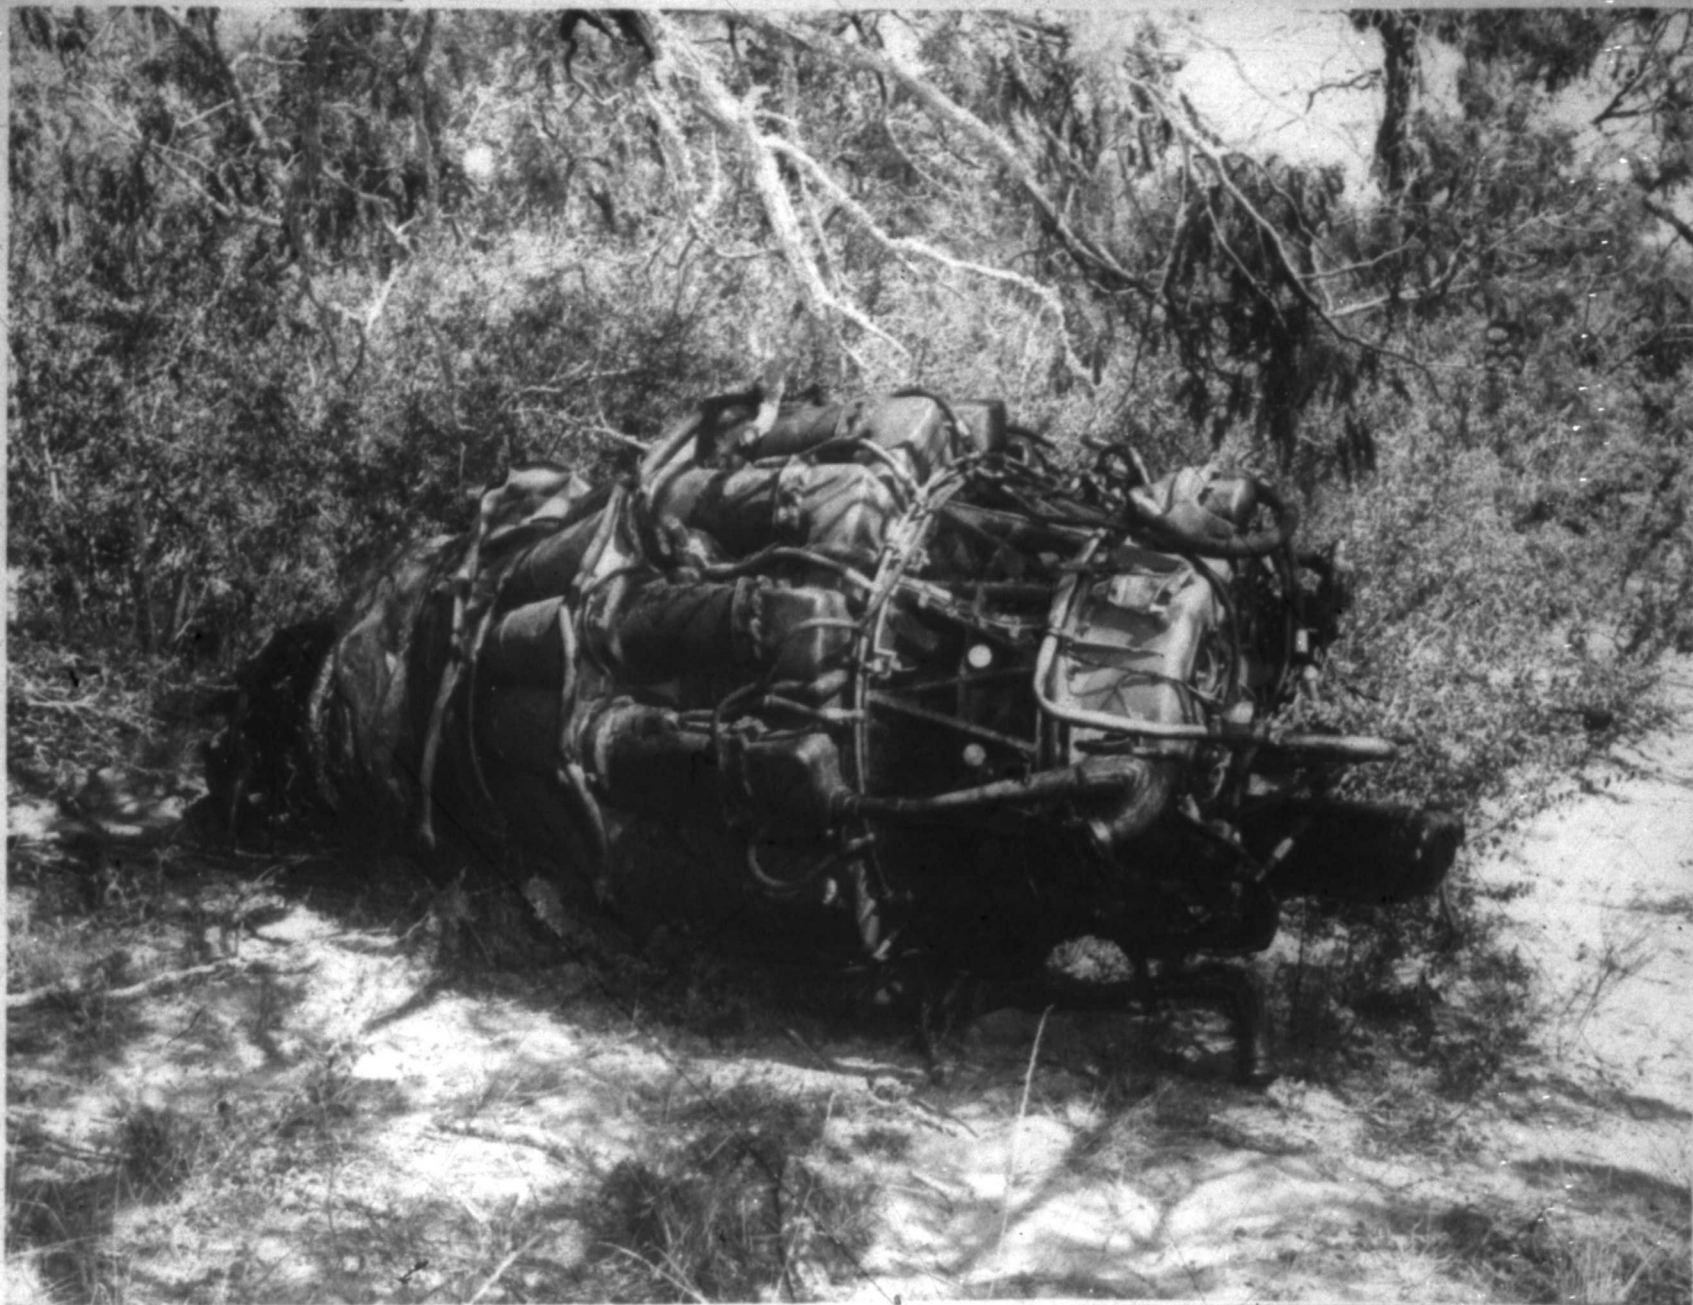
E. The engine was not running on impact and suffered very little damage. It was examined by O&R and judged to be capable of proper operation.

ENCL (15) AAR 13-57 TV-2 BU#138043. VIEW OF ENGINE SHOWING VERY LITTLE DAMAGE.
